The Potential of AI in the Evaluation of hospital infrastructure:

An Architectural and Technical Diagnostic Study Towards Future-Ready Healthcare

Giulio Altieri

Case Study: Les Champs Hospital (HUG)

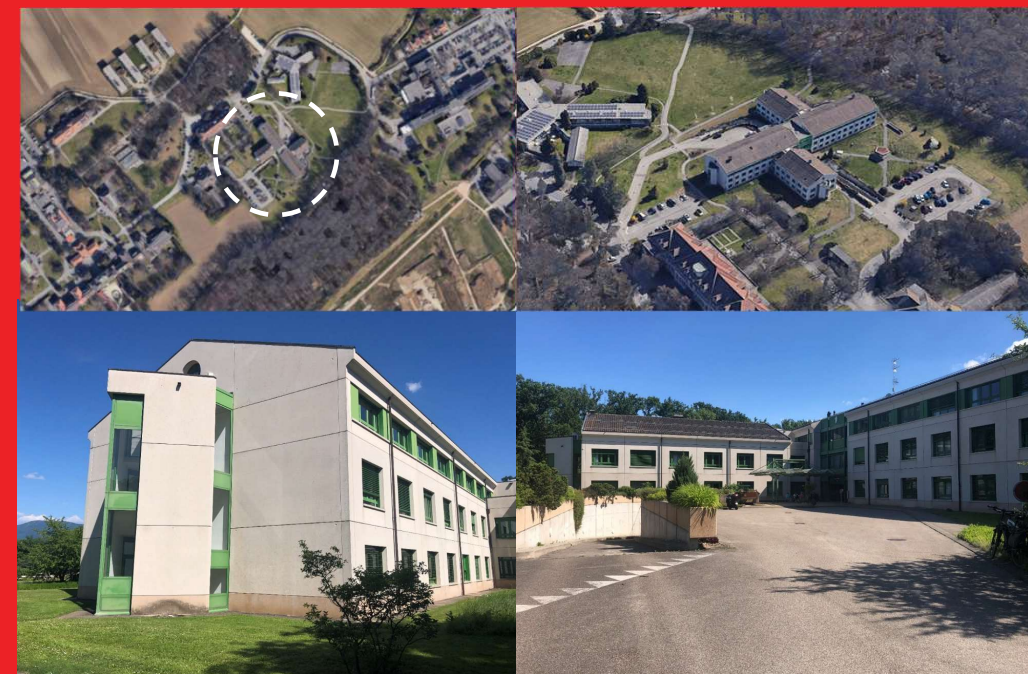
- Built 1990–1995, 8,000 m², 83 beds.
- Located in Belle-Idée campus, psychogeriatric specialization.
- Client: Hôpitaux Universitaires de Genève (HUG).

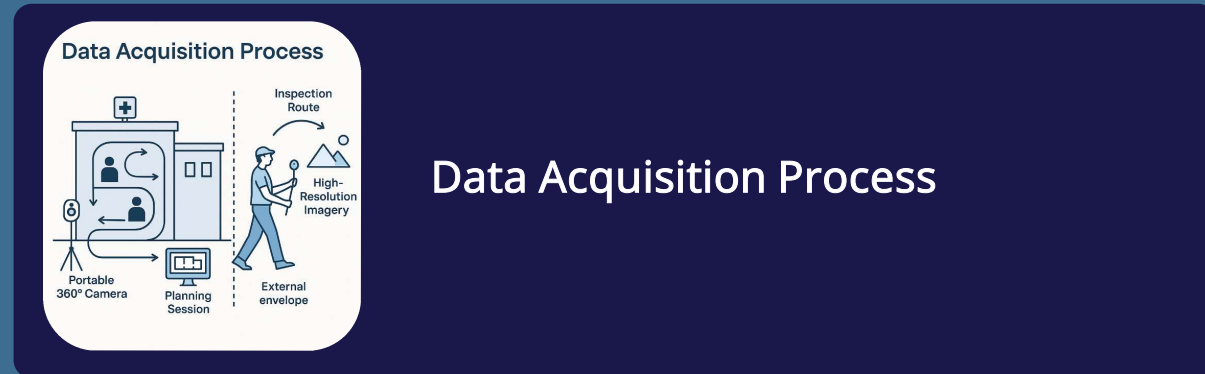
Data Acquisition Process

- Integrate AI-based defect detection and cost modeling.
- Interior & Exterior Inspector (360° imagery + CNN).
- Scan duration: 80 minutes.
- Upload → AI analysis → report within 48 hours.
- Automated detection, classification, severity scoring.

- Non-intrusive 360° imaging suitable for sensitive care settings.
- Full interior & exterior coverage.
- No scaffolding, no disruption to hospital operations.

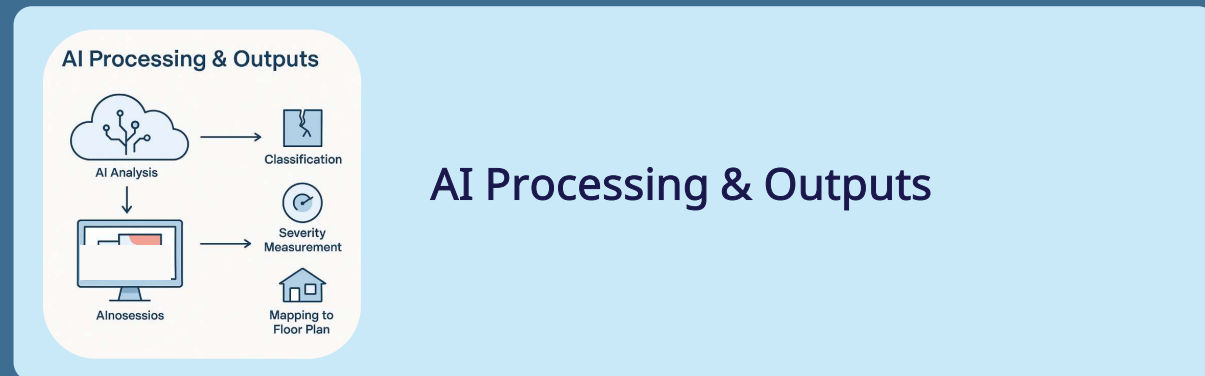
AI Processing & Outputs

- Defects tagged with ID, type, severity, material.
- Geo-referenced mapping and 3D visualization.
- Integrated with BIM and digital twin environments.

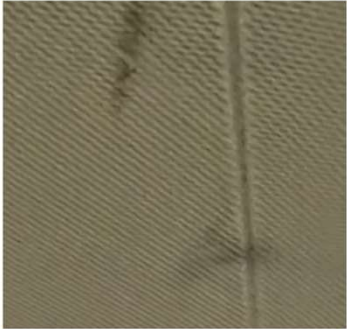
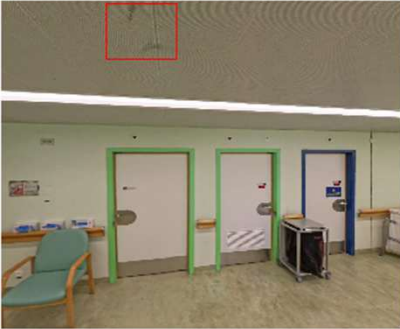
Description Soiling / Staining / Surface Deposits	Material Aluminium	Severity Safe	Condition Score 1 - Excellent condition	Intensity Developed	Other Comments Stain on ceiling	Solution Scrape off the paint and repaint the ceiling with existing colour scheme of the ceiling.

S/N 5	 					 
Description Open joints	Material Plasterboard / Calcium Silicate Board	Severity Require Repair	Condition Score 2 - Good condition	Intensity Developed	Other Comments Gap between the wall panels	Solution Fill with appropriate filler material to seal off the gap

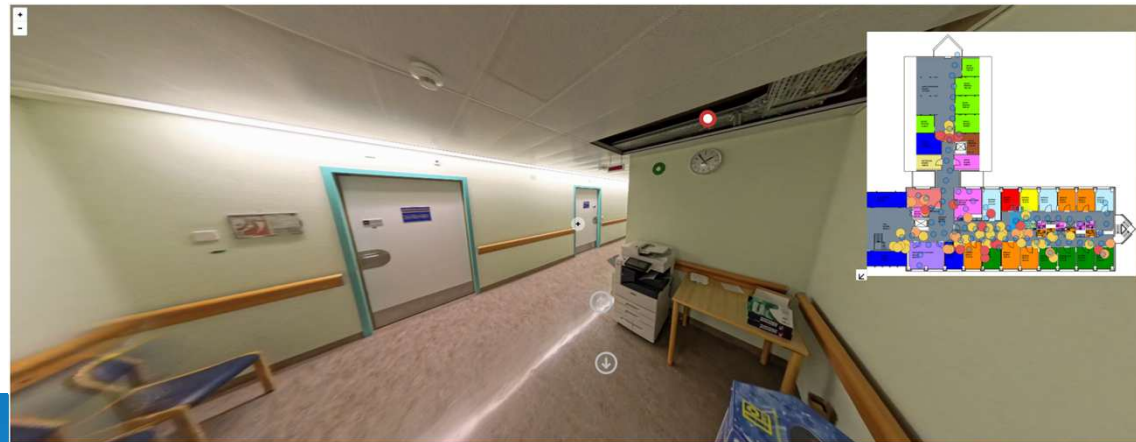
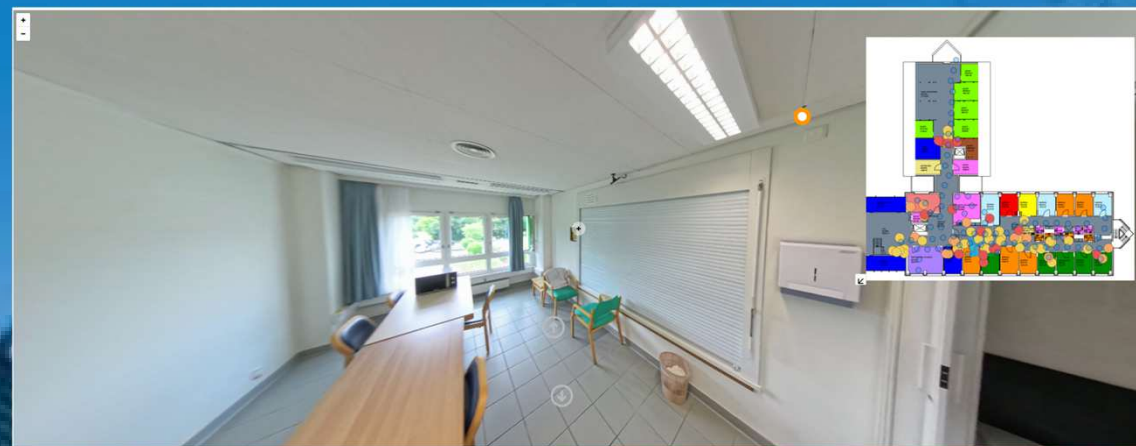
Digital Twin Visualization

- Interactive web-based model for remote access and validation.
- Enables multidisciplinary collaboration (architects, engineers, clinicians).
- Strengthens transparency and planning efficiency.
